NBSIR 73-160

# **Examination of Failed Six Inch Cast Iron Pipe Natural Gas Main, Atlanta Gas Light Company, Atlanta, Georgia**

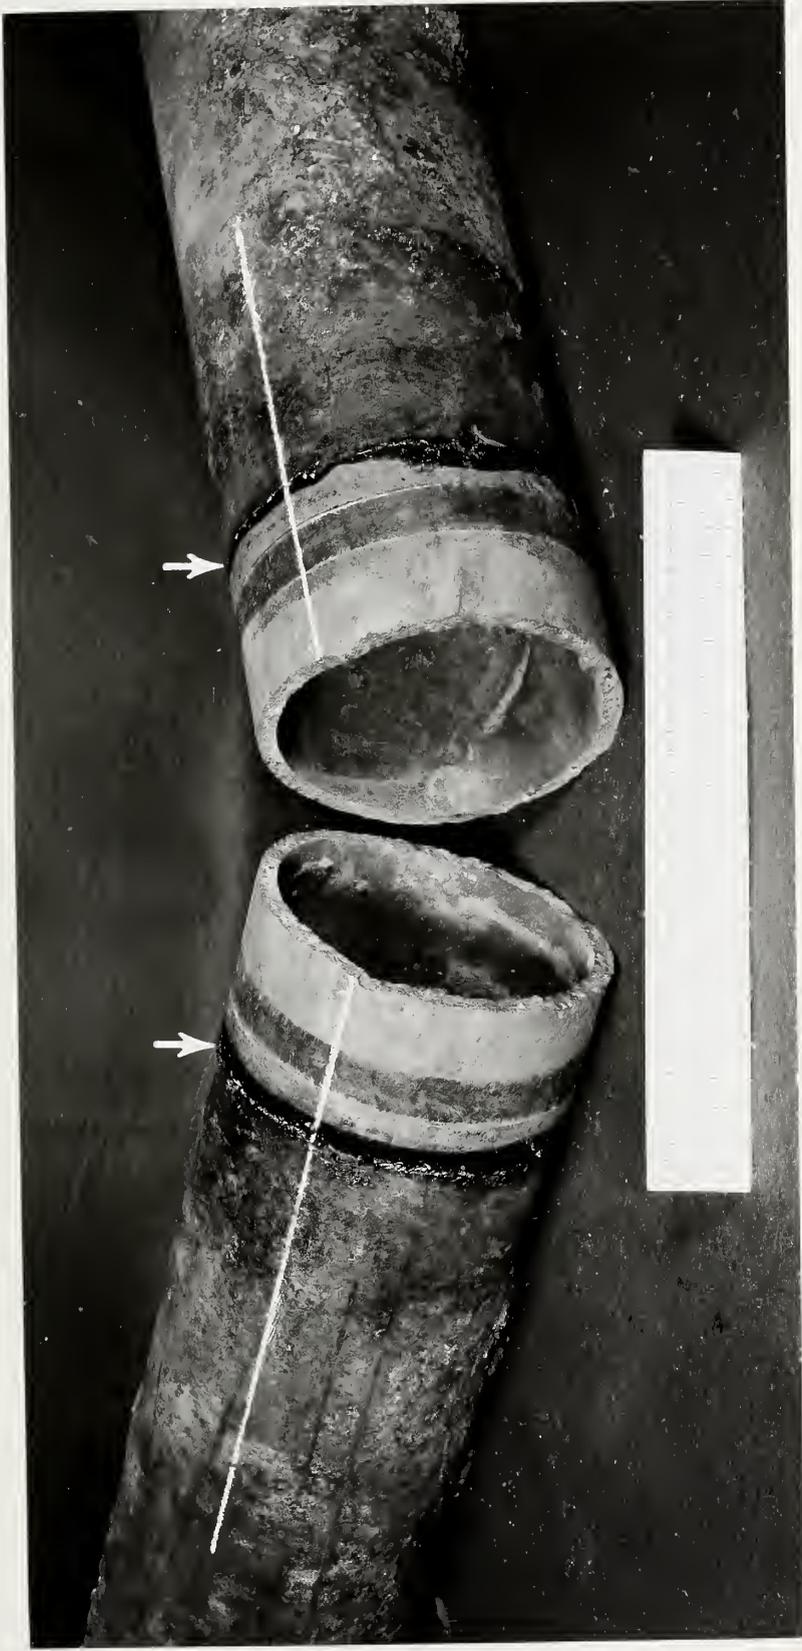
Figure 2. View of the two fractured pieces of pipe with the coupling removed. The white lines indicate the top of the pipe. The black rings (arrows) are apparently sealing compound applied when the coupling was installed. The pipe surface is relatively clean where the coupling had been. Smallest division of lower scale = 1/16 inch.

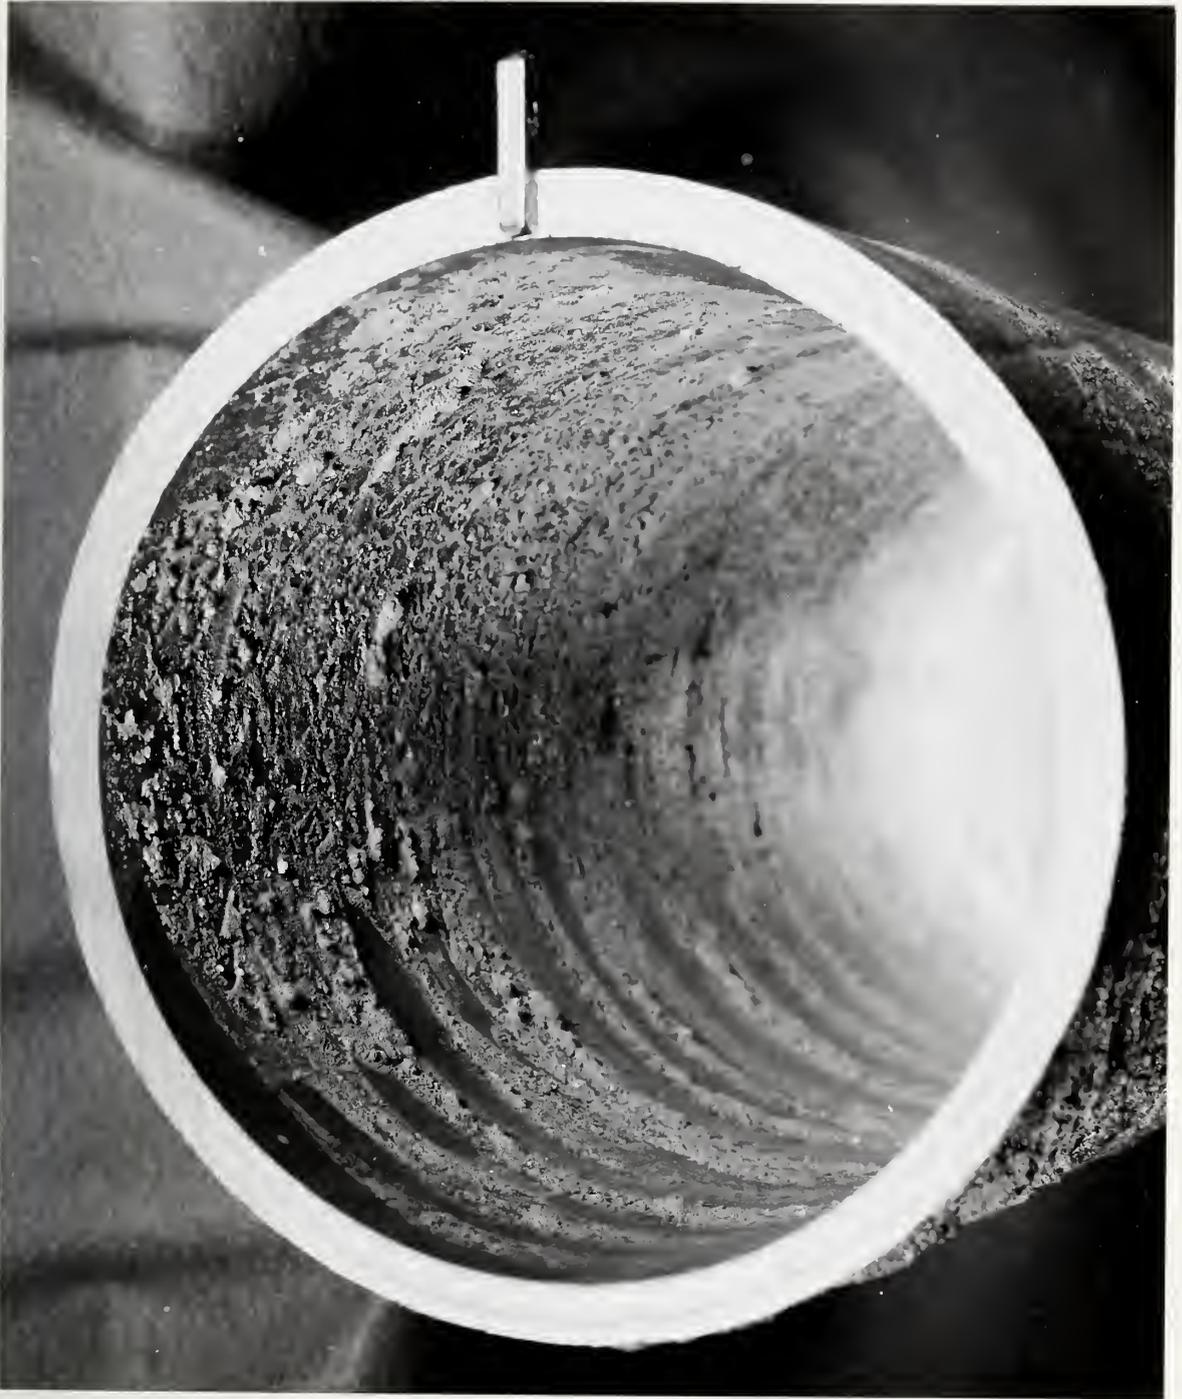
Figure 3. View of the inside of one of the fractured pieces of pipe showing the sand deposits primarily between six o'clock and twelve o'clock. The marker is at the twelve o'clock (top) position of the pipe as it was located in service. X 1

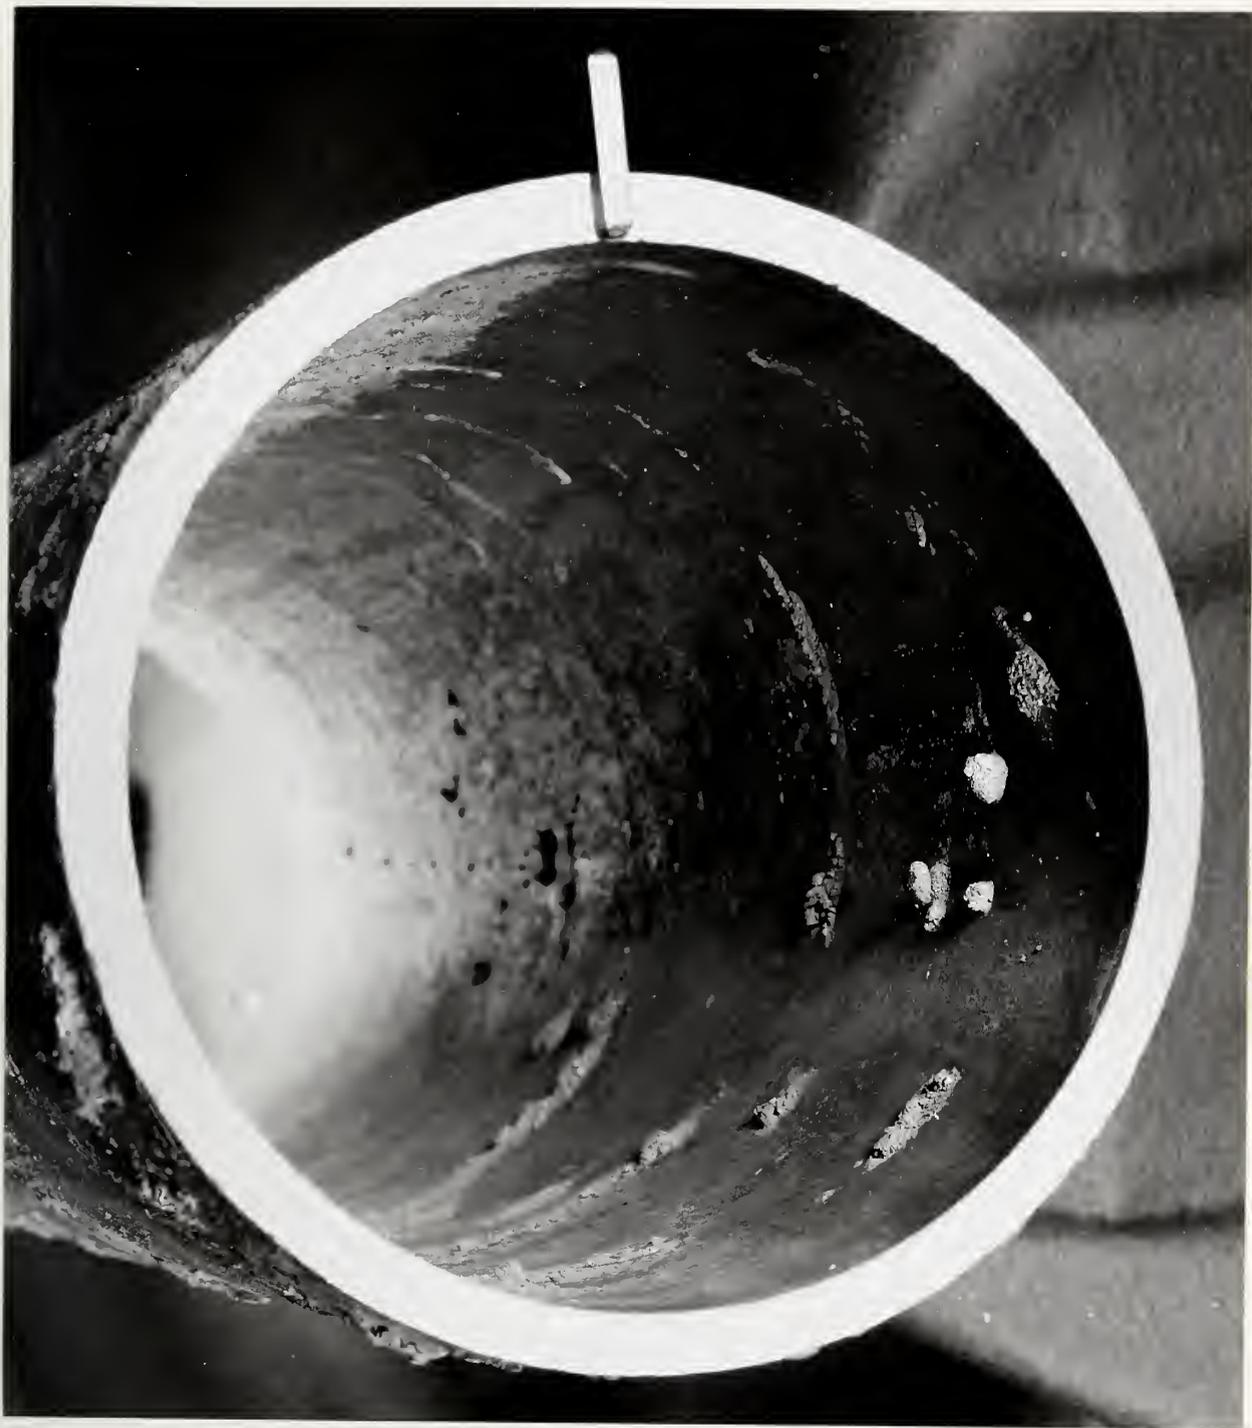
Figure 4. View of the inside of the same fractured piece of pipe as shown in figure 3 showing the sand deposits primarily between twelve o'clock and six o'clock. The marker is at the twelve o'clock (top) position of the pipe as it was located in service. X 1

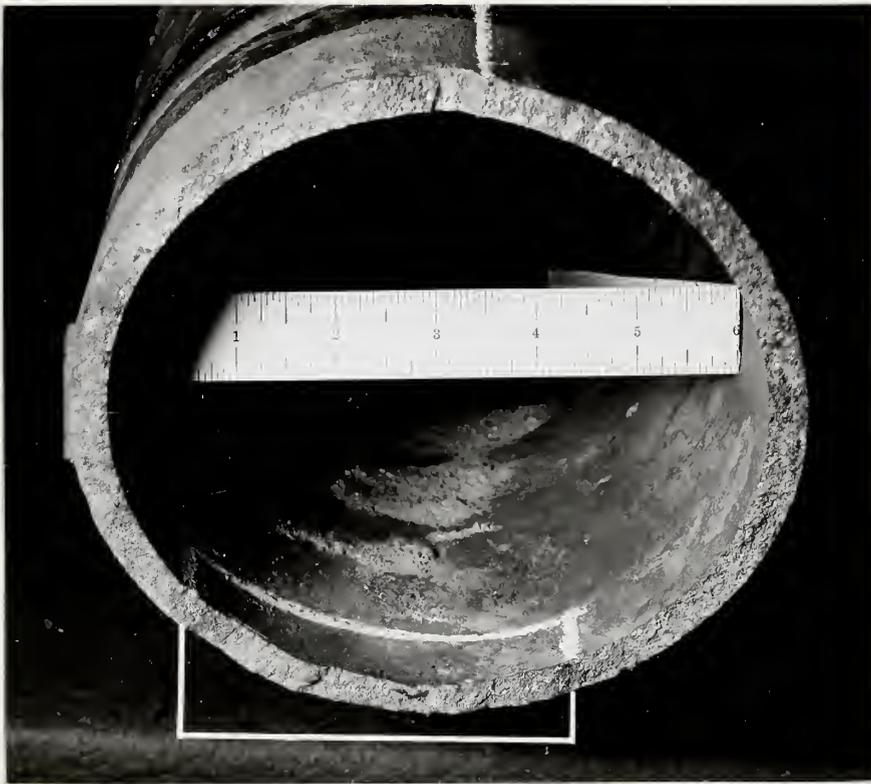
Figure 5. One of the fracture faces. Bracketed region had the appearance of fresh fracture. Un-bracketed region was covered with what appeared to be yellow clay soil. Smallest division of scale = 1/16 inch.

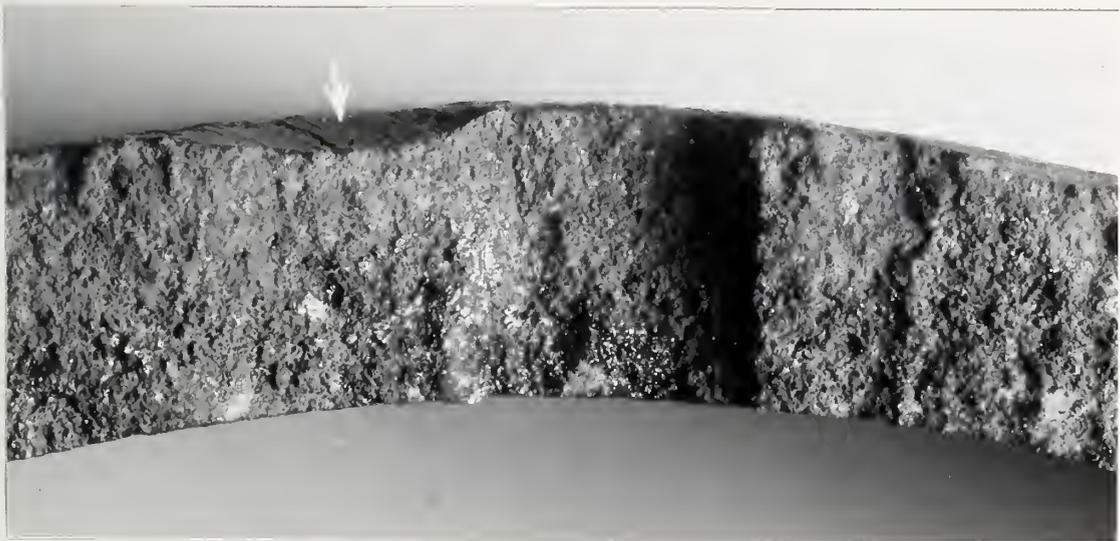
Figure 6. Fracture surface at top of pipe. Arrow indicates location of missing chip(s). X 4

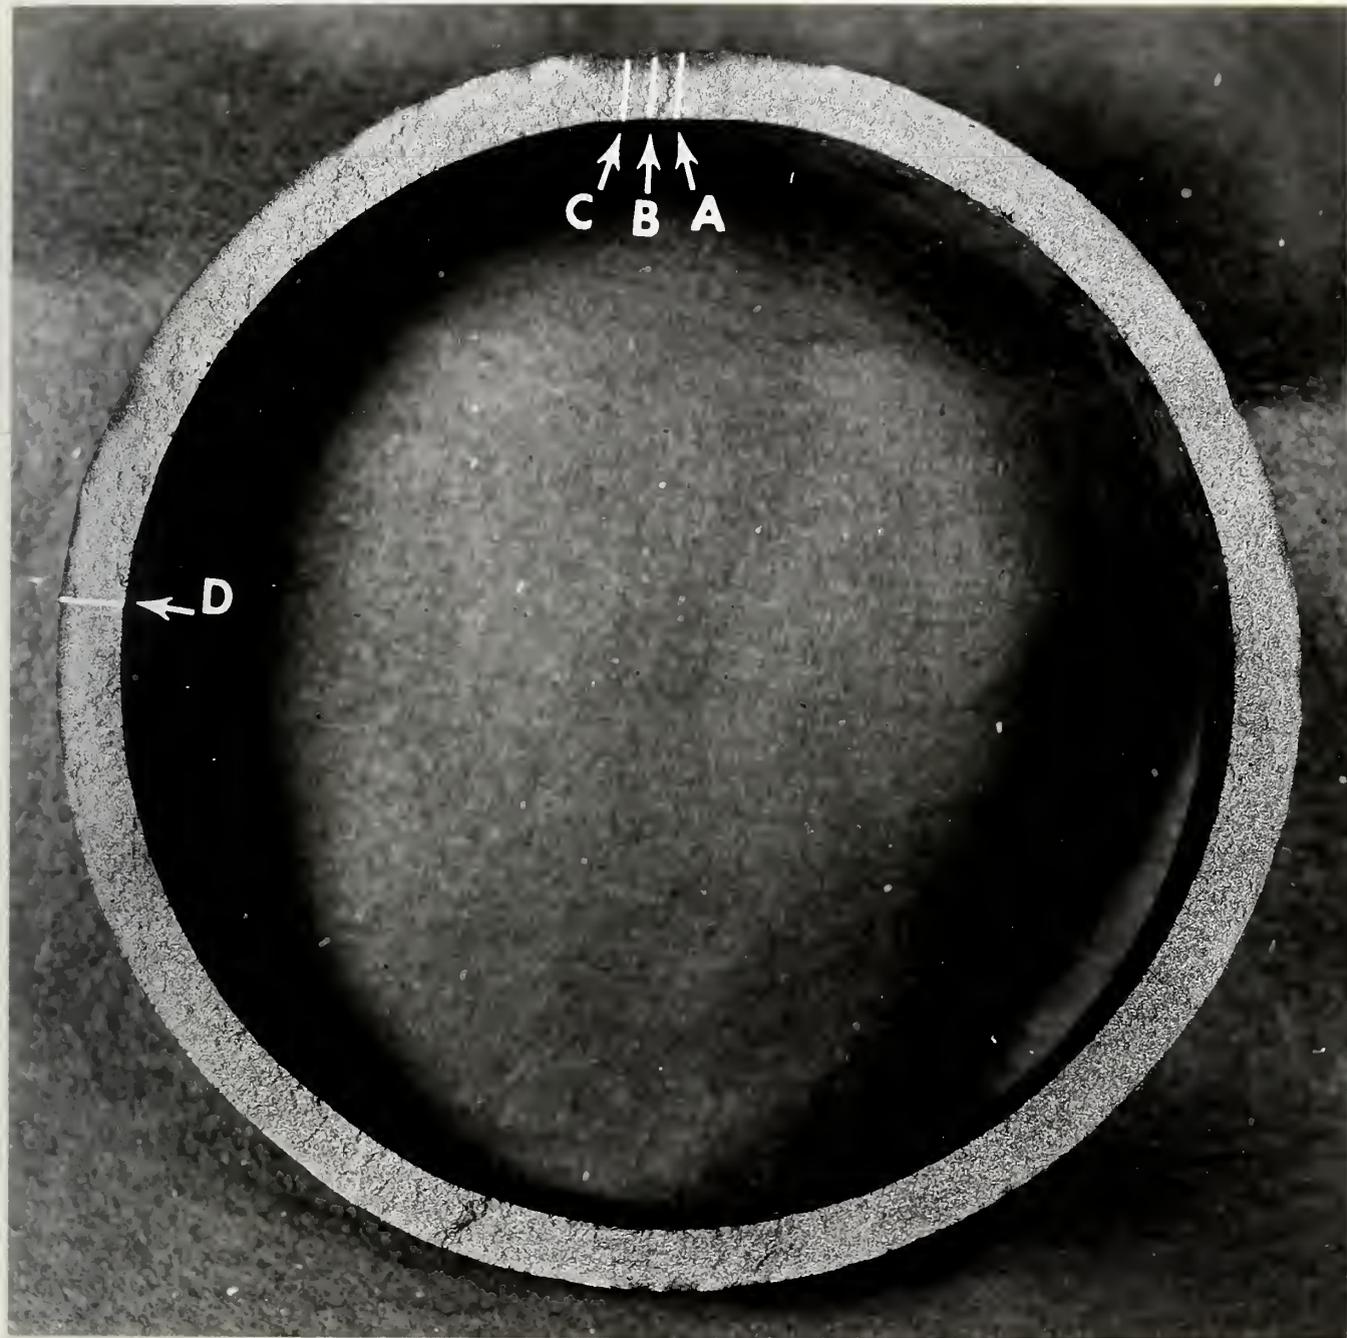
Figure 8. Entire fracture surface after cleaning. Arrows A, B, C, and D indicate locations of longitudinal cross sections cut from the pipe for macroscopic and metallographic examinations. Top of pipe is at top of photograph.  
X 1

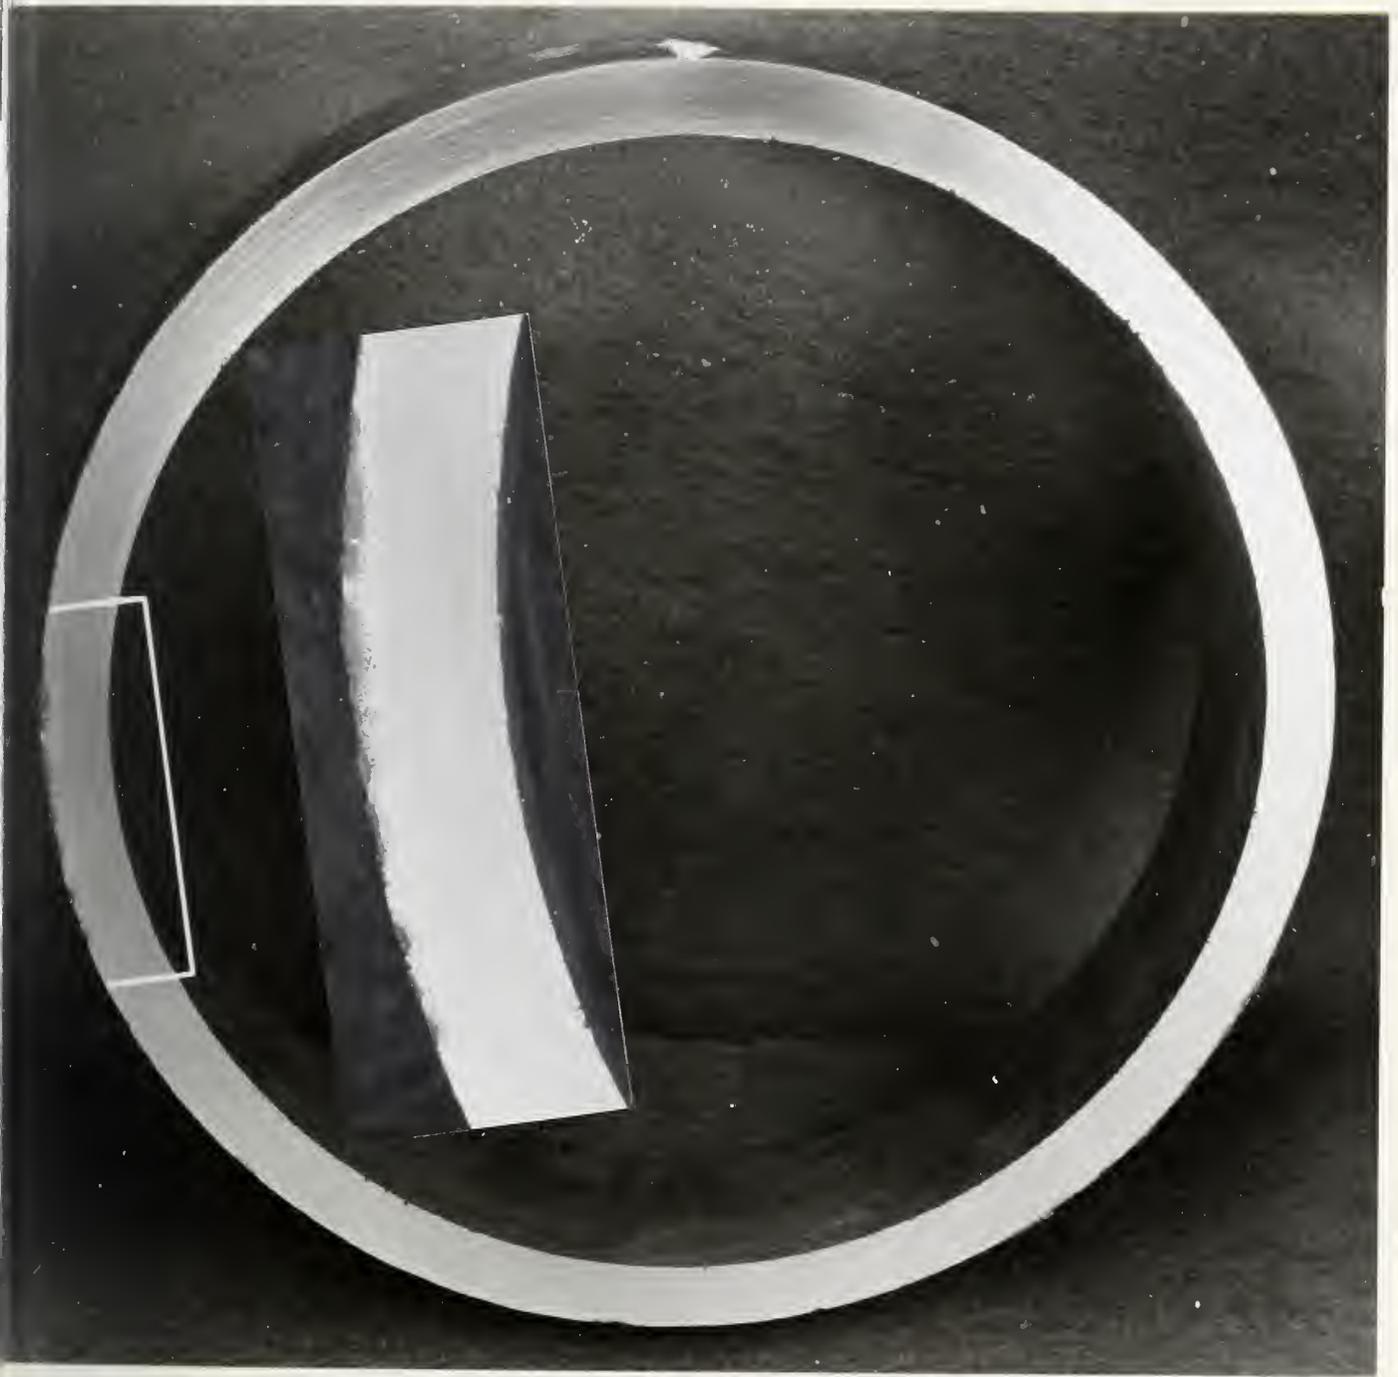
Figure 10. Polished transverse slice about one inch from the fracture surface. Top of pipe is at top of figure. Some areas of graphitization can be seen adjacent to the outside surface of the pipe. These areas are darker than the adjacent material where there is no graphitization. The bracketed area contains the deepest penetration of graphitization in this slice. This area is shown at a higher magnification (X 2) in the insert. X 1

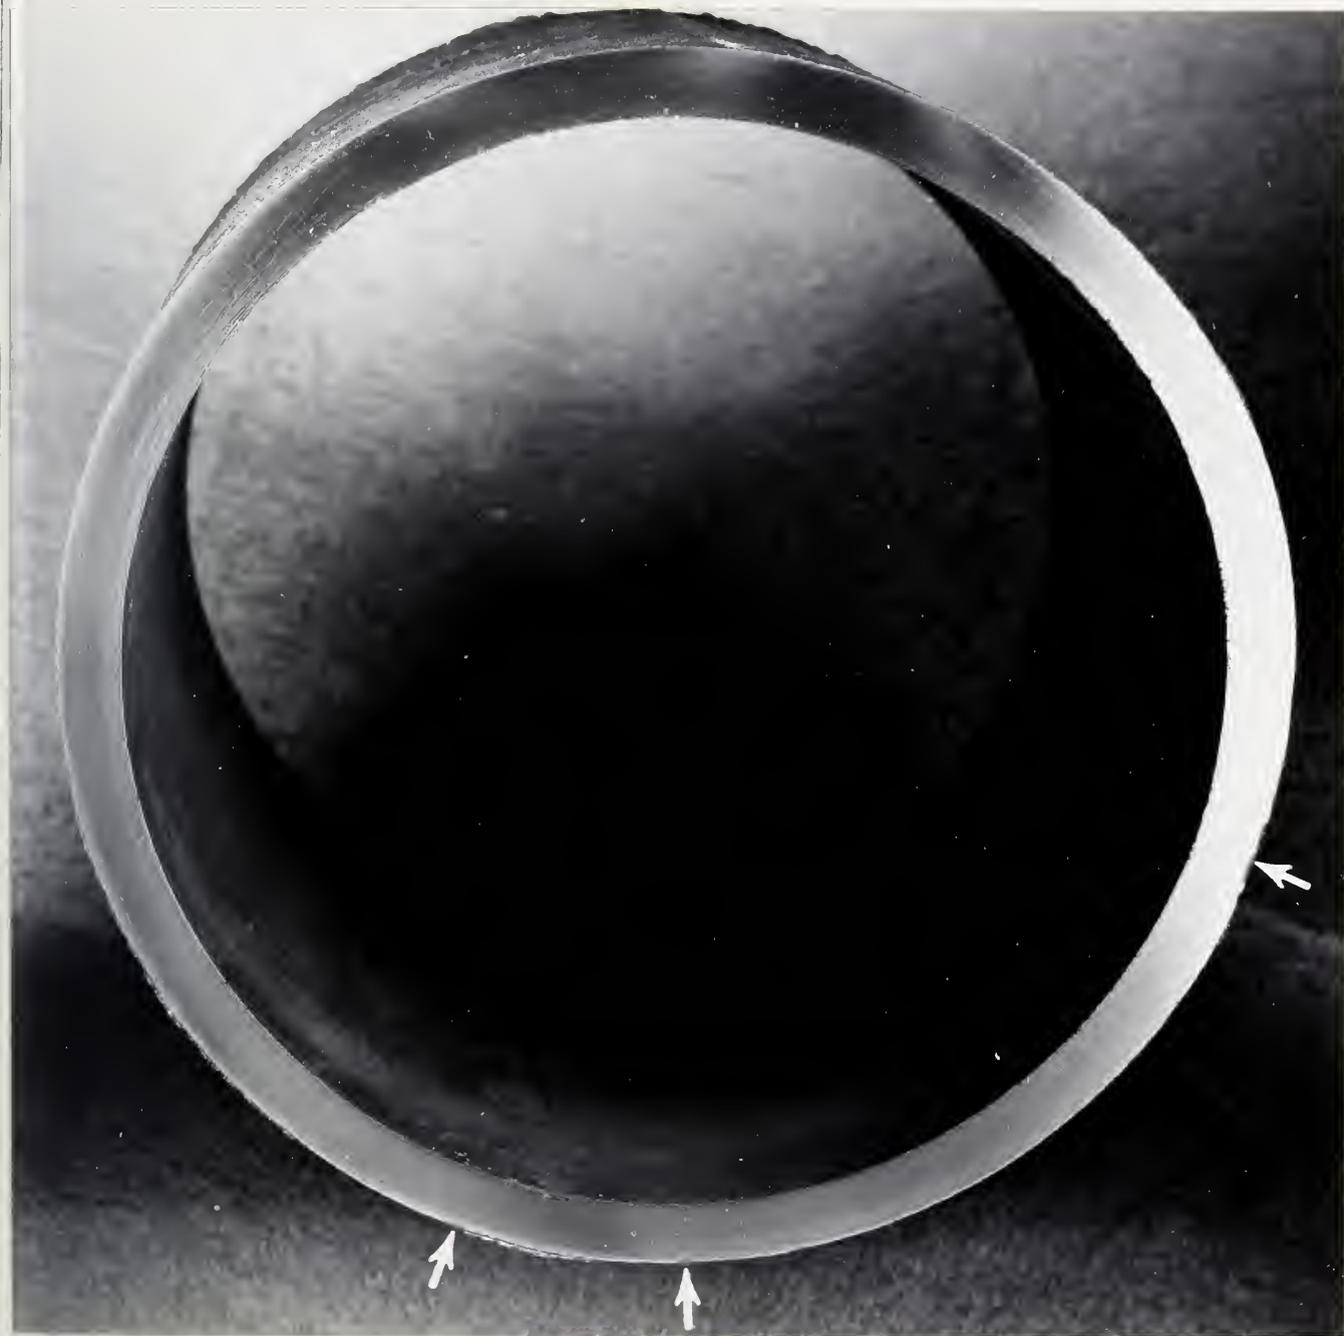
Figure 11. Polished transverse slice about eight inches from the fracture surface. Top of pipe is at top of figure. Some areas of graphitization (arrows) can be seen adjacent to the outside surface of the pipe. These areas are darker than the adjacent material where there is no graphitization. X 1

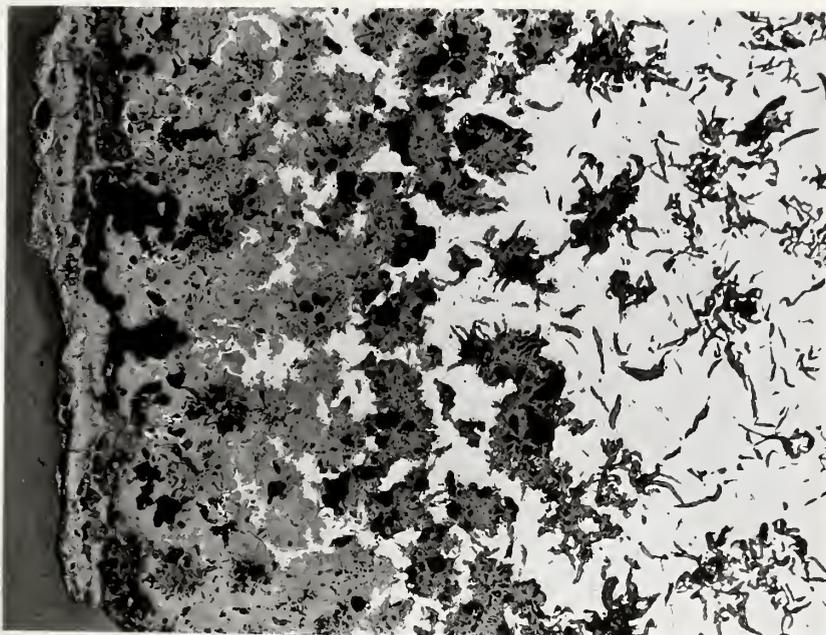
Figure 13. Unetched field from cross section D showing graphitization gradient. Graphitization is essentially complete at the far left. There is no graphitization at the far right. X 40

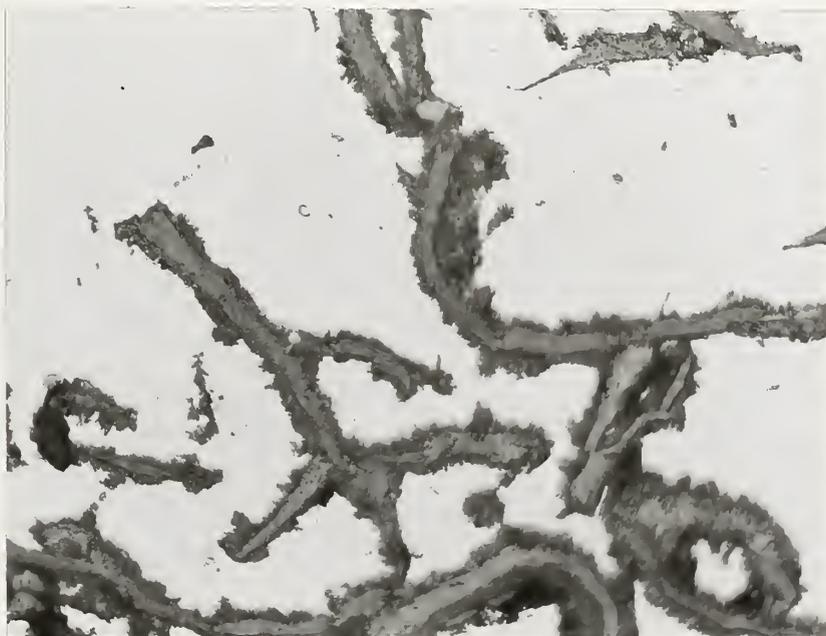
Figure 14. Unetched field from cross section B. Graphitization is just beginning here. There is a considerable amount of corrosion product surrounding the graphite flakes. X 500

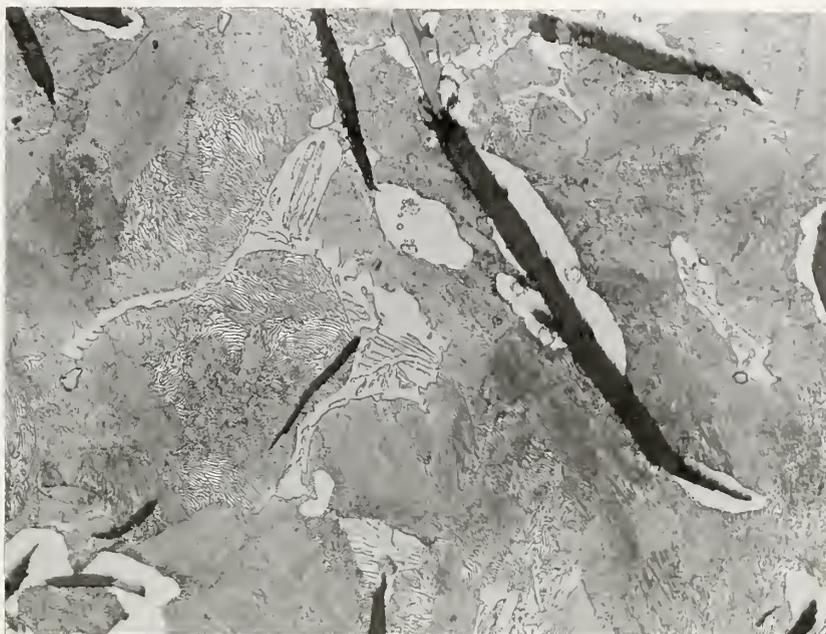
Figure 15. Etched field from cross section D near inside wall surface. Microstructure consists of graphite flakes partially surrounded by ferrite in a matrix of pearlite and iron-iron phosphide eutectic. Etch: 3% nital. X 500

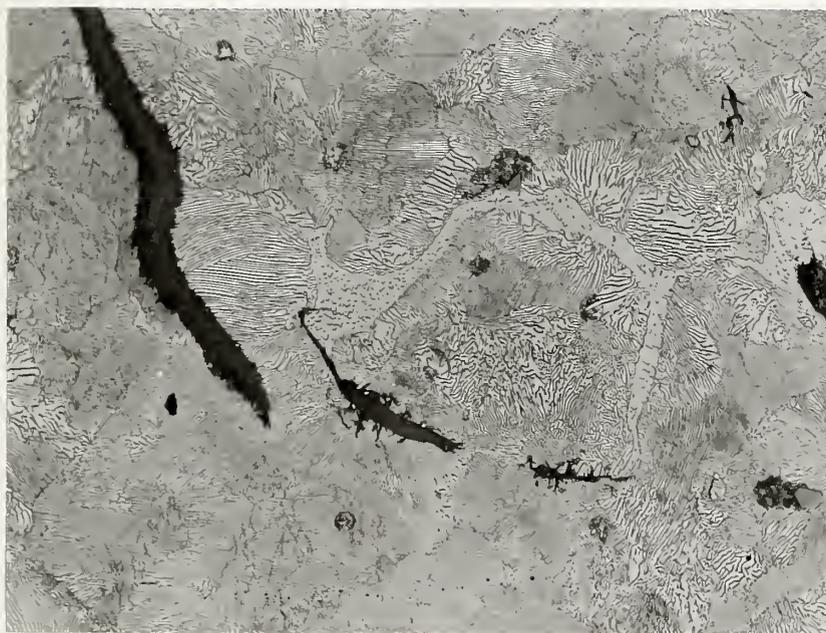
Figure 16. Etched field from cross section D about midway between inside and outside wall surfaces. Microstructure consists of graphite flakes in a matrix of pearlite and iron-iron phosphide eutectic. Etch: 3% nital. X 500

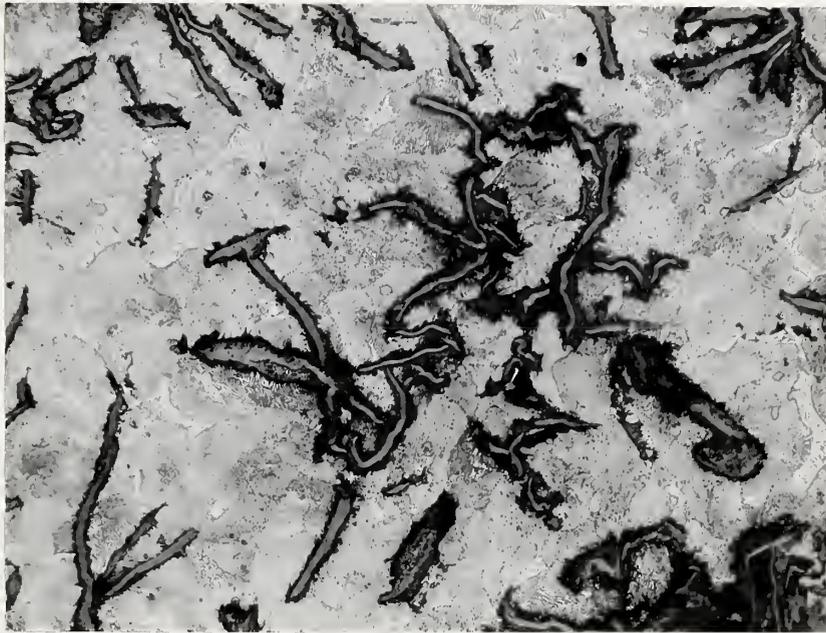
Figure 17. Etched field from cross section D in an area where graphitization is beginning. The graphite flakes are surrounded by corrosion product. The matrix is primarily pearlite and iron-iron phosphide. Etch: 3% nital. X 200

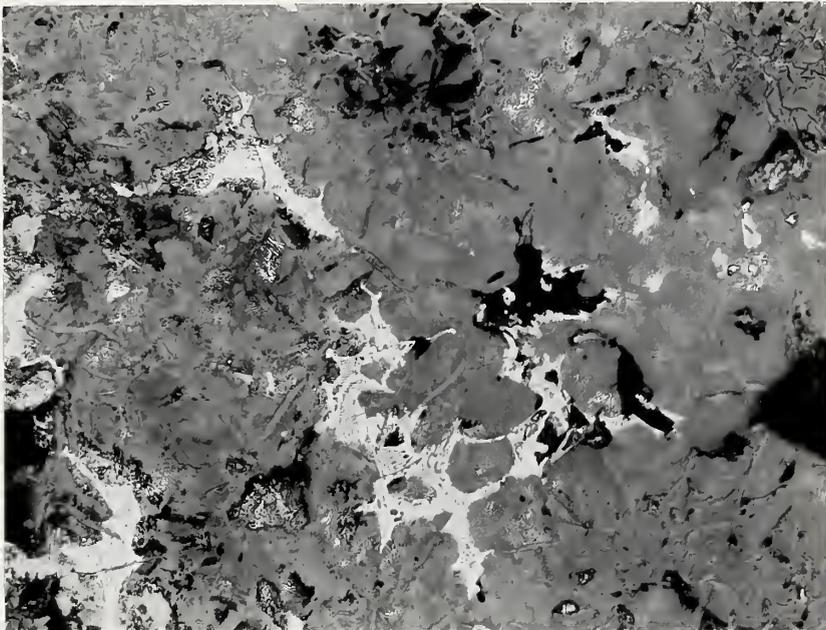
Figure 18. Etched field from cross section D in an area where graphitization is nearly complete. Small patches of the matrix remain. Etch: 3% nital. X 200
